SUN EDEN COMMUNITY

STORM DRAIN SYSTEM (MOE)

124 UNITS
(W.C.A) 72 HOUSES
(W.T.A) 52 TOWNHOUSES

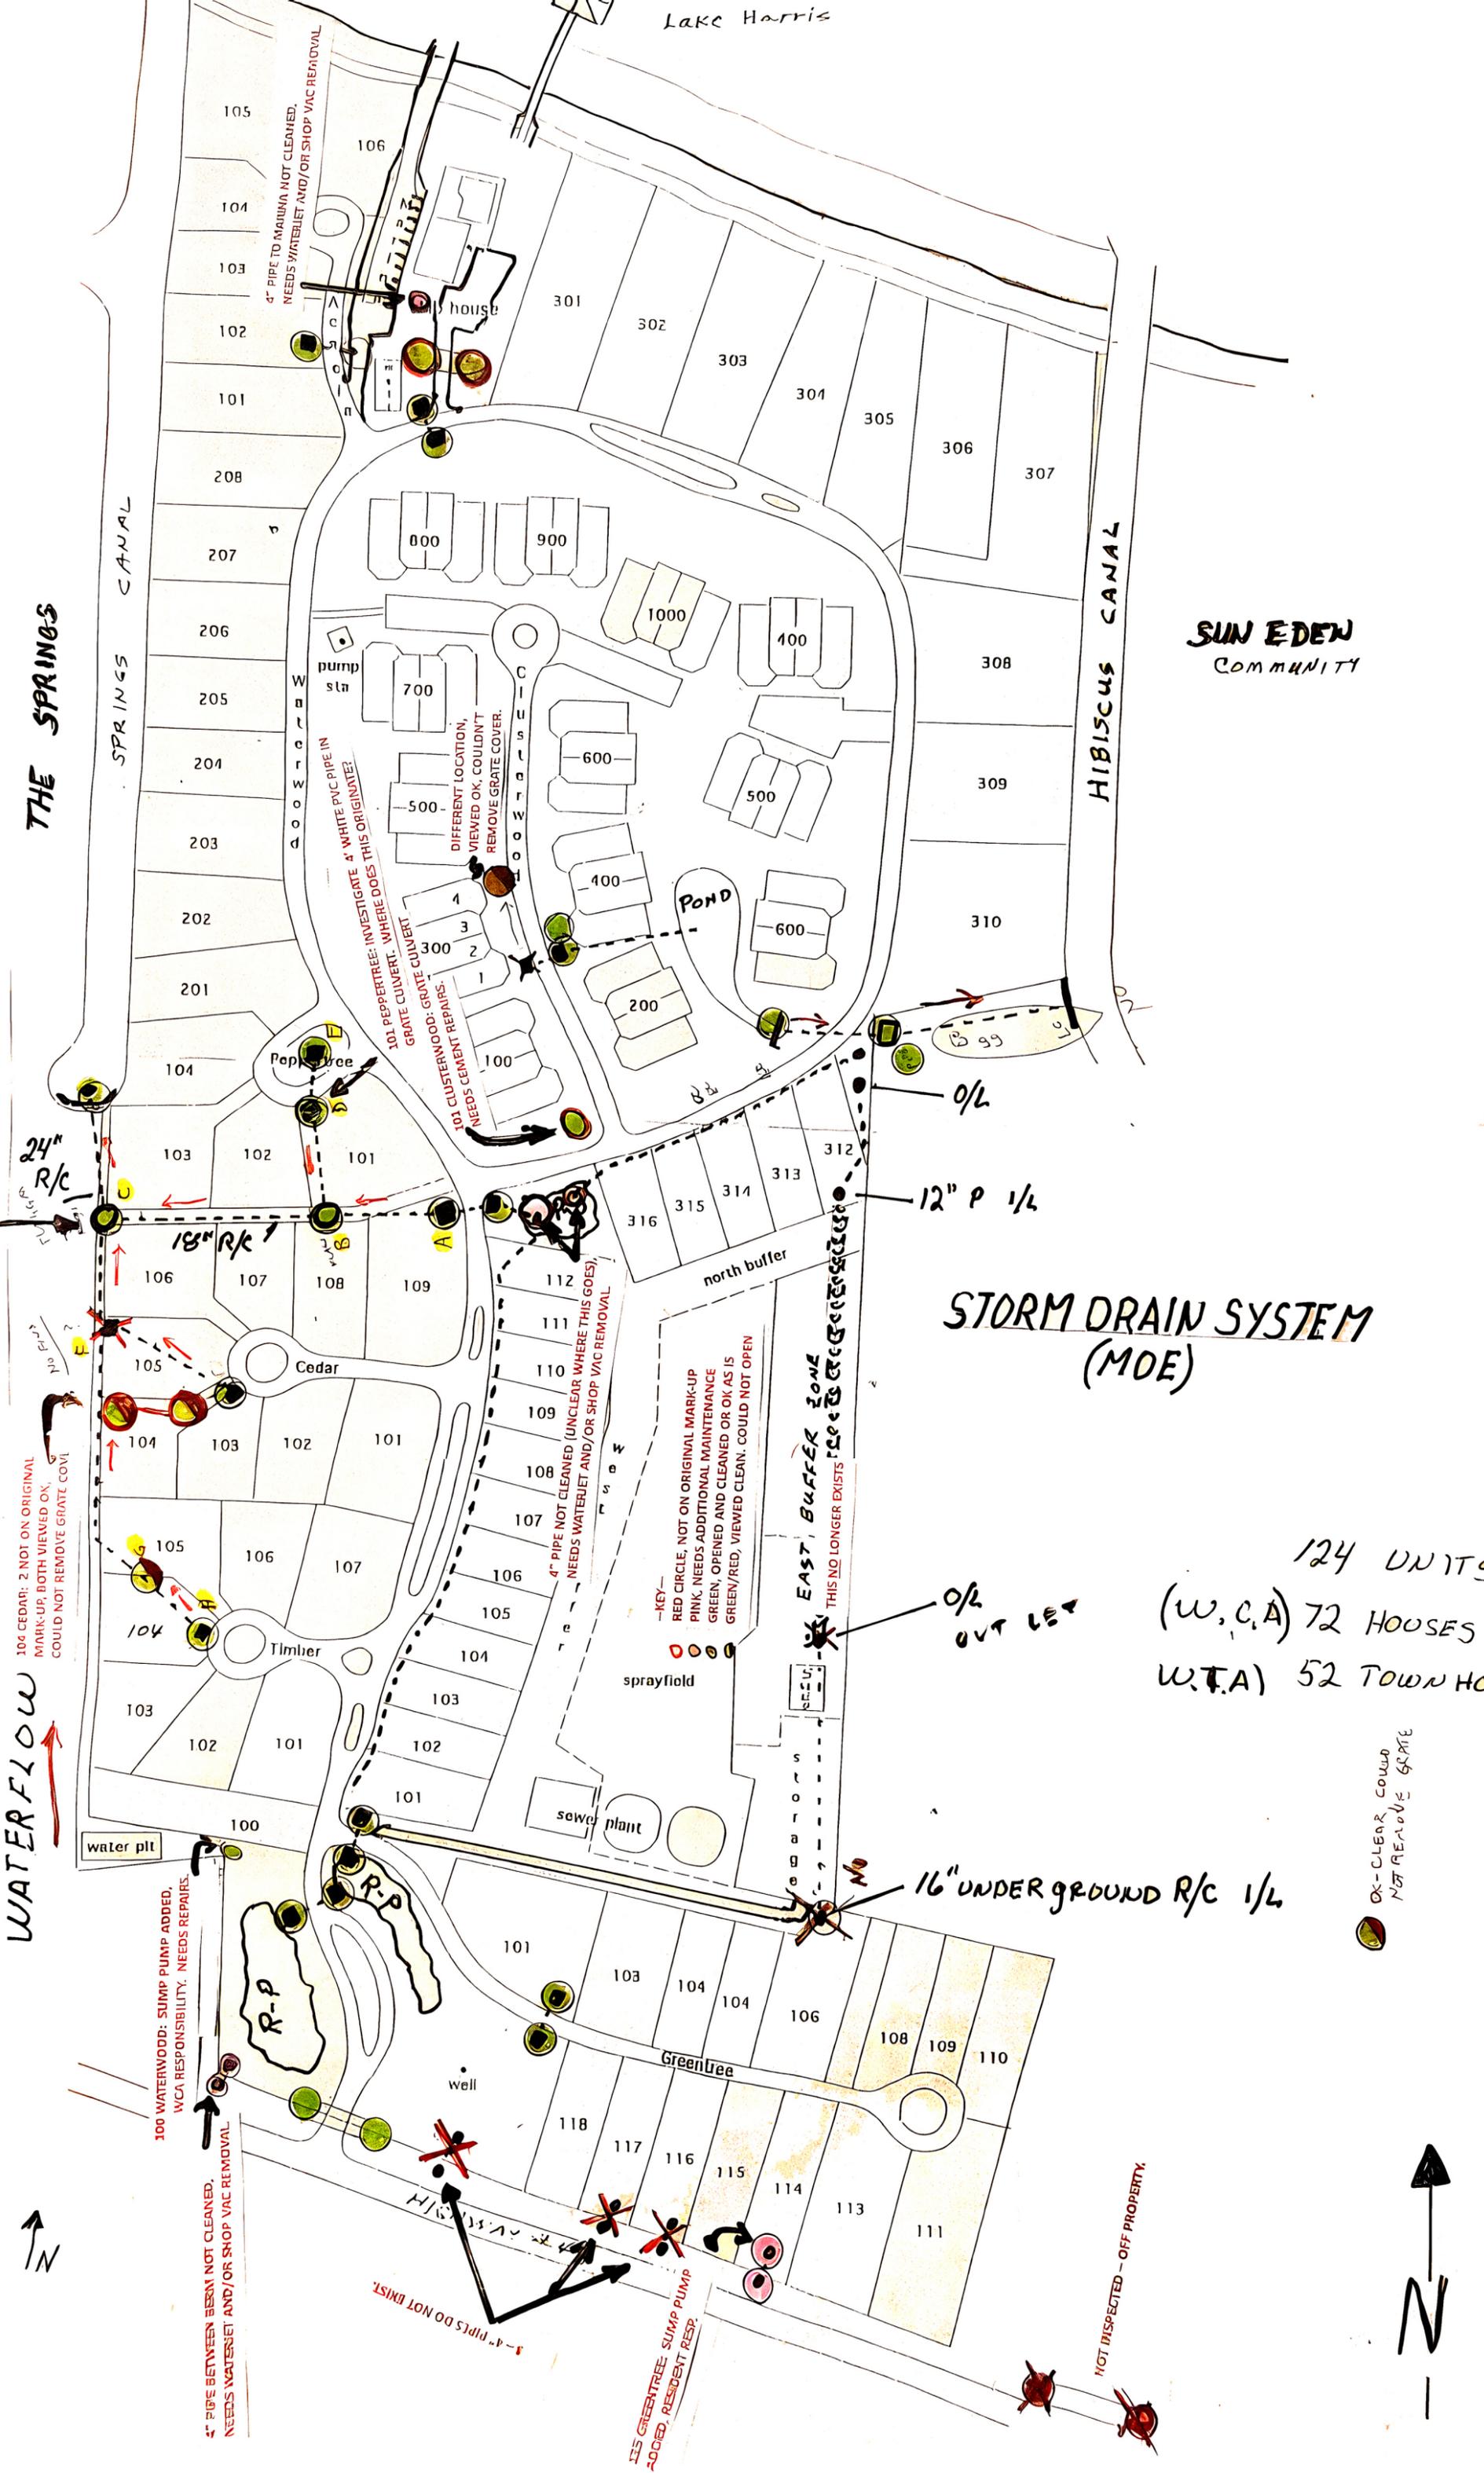
103 PEPPER TREE: GRATE CULVERT NEEDS CEMENT AND REBAR REPAIRS THIS WAS MODIFIED TO LOWER STANDING WATER BETWEEN HOMES.

104 CEDAR: 2 NOT ON ORIGINAL MARK-UP, BOTH VIEWED OK, COULD NOT REMOVE GRATE COVER

100 WATERWOOD: SUMP PUMP ADDED, WCA RESPONSIBILITY. NEEDS REPAIRS.

4" PIPE BETWEEN BERM NOT CLEANED, NEEDS WATERJET AND/OR SHOP VAC REMOVAL

4" PIPE TO MAINLINE NOT CLEANED, NEEDS WATERJET AND/OR SHOP VAC REMOVAL

101 PEPPER TREE: INVESTIGATE 4" WHITE PVC PIPE IN GRATE CULVERT. WHERE DOES THIS ORIGINATE?

101 CLUSTERWOOD: GRATE CULVERT NEEDS CEMENT REPAIRS.

DIFFERENT LOCATION, VIEWED OK, COULDN'T REMOVE GRATE COVER.

4" PIPE NOT CLEANED (UNCLEAR WHERE THIS GOES), NEEDS WATERJET AND/OR SHOP VAC REMOVAL

EAST BUFFER ZONE THIS NO LONGER EXISTS

OK - CLEAR, COULD NOT REMOVE GRATE

NOT INSPECTED - OFF PROPERTY
